NASA Engineering and Safety Center Technical Consultation Report	Document #: RP-06-115	Version: 1.0
Title: ISS S-Band Corona Discharge Anomaly Consultation			Page #: 1 of 26

International Space Station (ISS) S-Band Corona Discharge Anomaly

December 14, 2006

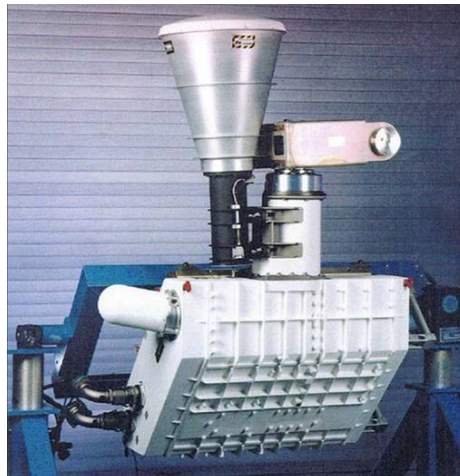
Figure 6.1-1. S-Band Assembly Contingency RF Group (ref. 5)

On April 13, 2006, there was a reflected RF power anomaly observed after four minutes nominal operation within the ACRFG (refer to Figure 6.1-1). This was in the “String 1 RFG” unit on S1 (S/N 002) as shown on the ISS in Figure 6.1-2. The “String 2 RFG” unit (S/N 003) on P6 is the primary unit. The spare unit (S/N 001) is stowed on Z1. Corona was examined as a possible root cause of the anomaly. Section 3.5 of the MDA ACRFG Reflected RF Power Anomaly Report (ref. 1) determined the necessary voltages to produce corona, at various pressures, in the narrowest electrode gaps in the coaxial cavity 5-pole diplexer and 3-pole bandpass filter (see Figure 6.1-3) assemblies. The results of the MDA analysis suggest the conditions present in the Bandpass Filter and Diplexer at 1 psia may have been favorable for the corona.

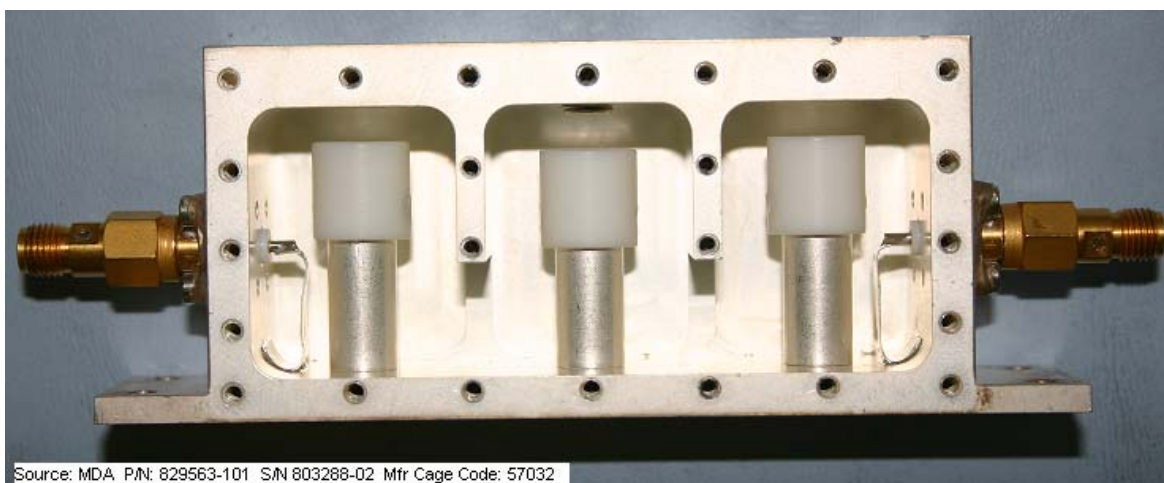
Figure 6.1-3. Bandpass Filter Assembly (ref. 5)

The MDA report had concluded that a solder joint failure at the input of the bandpass filter was the most likely proximate cause of the on-orbit anomaly. The NESC Team noted that it is

possible that corona inside the filter cavity could erode (or more likely melt open) the solder connection attaching the injection loop's end to the case-wall, leading to a separation and result in observed signal loss. If the solder melted, or even reached the softening temperature, then the residual stresses in the loop (shown in Figure 3.2-2, page 16 of the MDA report) could allow separation. This hypothetical detachment would also drop the voltage level in the cavity below the value needed to sustain the corona, at least for the present pressure. If this solder connection separation has happened, then there can be no further corona until the pressure decreases enough to move the system far enough along the Paschen curve so that the plasma threshold drops to the now-available voltage level. The predicted time for this change in plasma threshold could be approximated from the measured leak rate and the Paschen curve for N_2 .

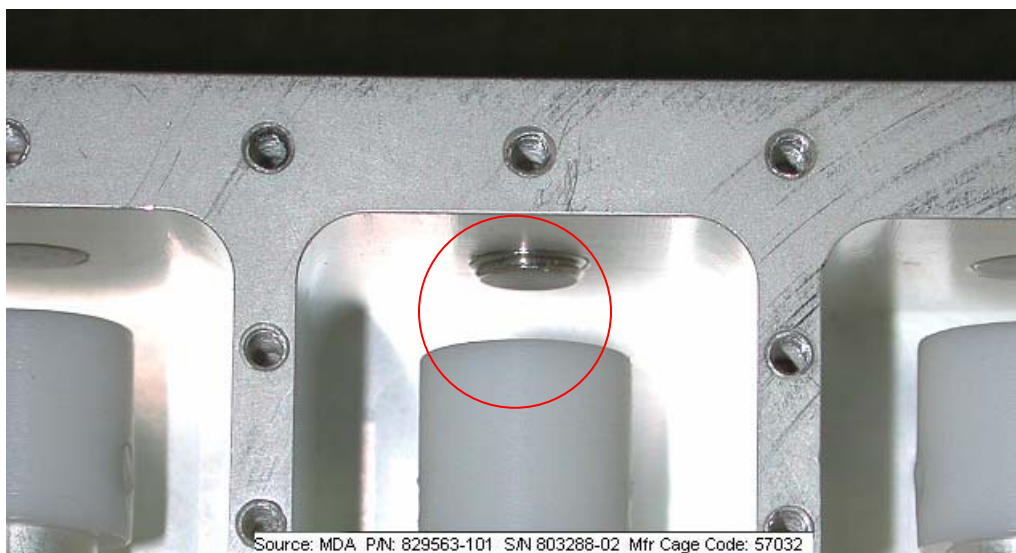
Figure 6.1-4. Bandpass Filter Tuning Screw and Gap (ref. 5)

However, corona was judged unlikely in the initial MDA report because of the observed on-orbit condition of four minutes of normal operation followed by degraded service. The end of Section 3.5 (ref. 1) states: "Corona events tend to be a violent occurrence and with permanent damage. Continued operation would not be sustained." For these reasons, a solder joint at the input to the bandpass filter was initially identified by MDA as the most likely proximate cause of the on-orbit ACRFG anomaly.

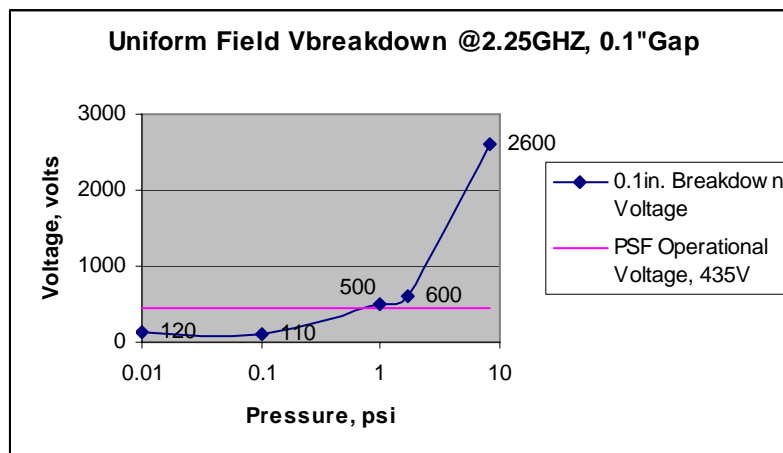
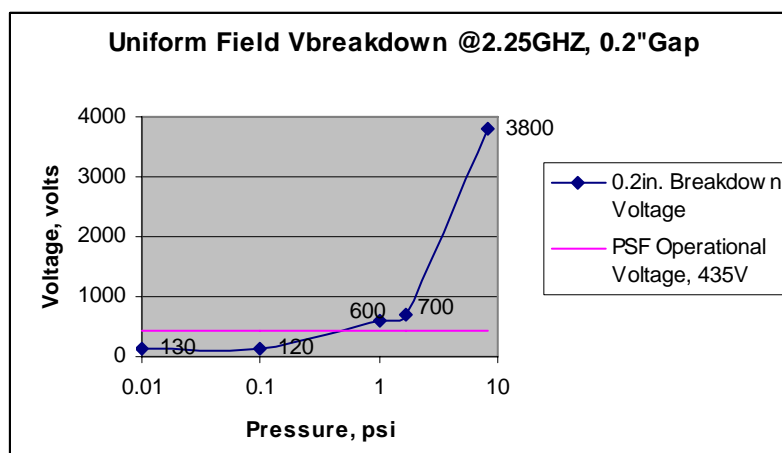
Figure 7.2-1. Breakdown Voltage versus Pressure for Various Gaps (in air) from Woo Curves (ref. 6)

The charts in Figure 7.2-1 show the RF breakdown voltages for a range of pressures in an air environment (refs. 5 and 6). For the purposes of this analysis, N₂ and air are considered

However, it can be seen that the worst case range is between 0.01 and 1 psia and the inception level is so low that corona is likely.

1. At pressures between 0.001 psia and 1 psia, corona is almost certain (>90 percent) for the gap sizes within these assemblies (>90 percent).
2. At pressures of greater than 2 psia, corona at any gap size is unlikely (<10 percent).
3. Between 0.1 and 1 psia, the margin between the operating voltage and corona inception level is essentially non-existent, and the likelihood of corona should be moderate (~70 percent).
4. Below approximately 0.001 psia, multipactor breakdown dominates over ionization breakdown. Corona does not occur in hard vacuum (e.g. <0.00001 psia). However, multipactor breakdown is still possible for small gaps (0.1 inch) in this pressure region, so a breakdown probability of 50 percent would be appropriate.

In the 1 to 2 psia region, the probability of corona is undefined. This is the “knee” of the Paschen curve where the breakdown voltage characteristic changes greatly with small changes in pressure.
